BACK FROM “BEYOND REPAIR”

CORSYS PLUS HAS PROVED ITS RELIABILITY

Specialists from the POLYPLASTIC Group were invited to visit a construction site of a 3 km sewer pipeline made of CORSYS PLUS pipes (D: 2200 mm).

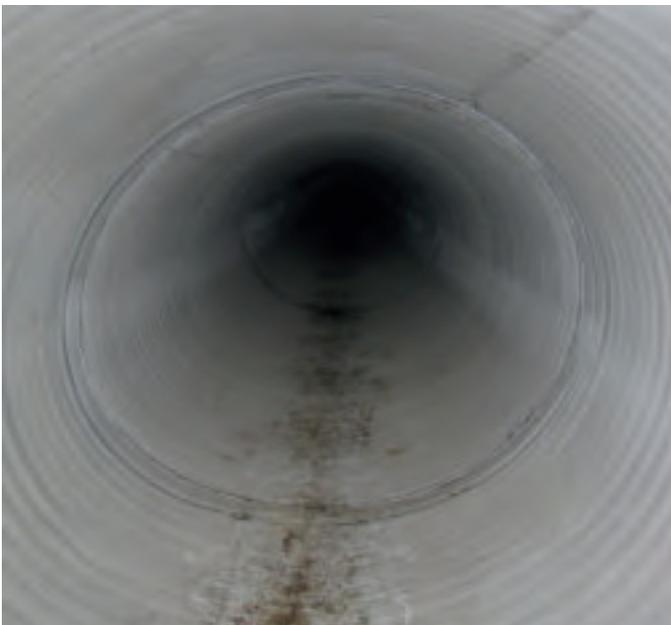
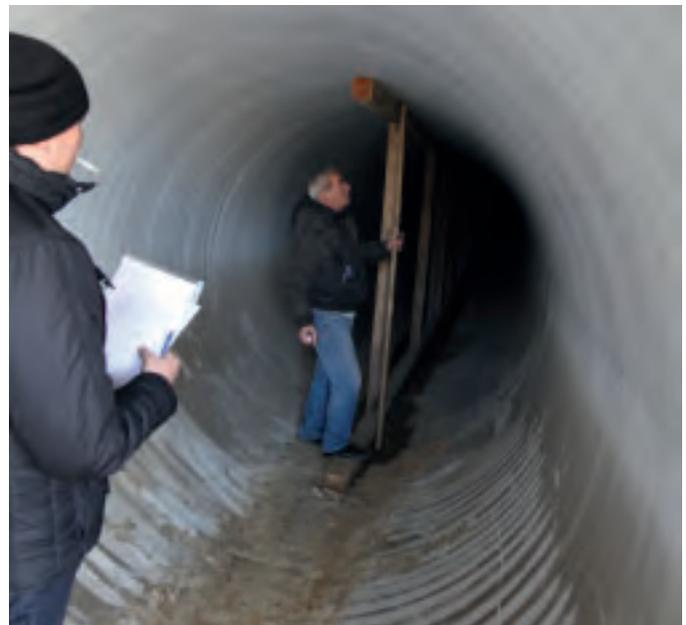
It had been discovered that one of the sections, about 300 metres out of the total length of 3 km, had an unacceptable level of ovality. In some places it reached 20% and could go beyond that given the movement of the heavy construction machinery above the pipeline.

The cause of the section deformation was obvious: the contractor did not follow their requirements for backfilling, ground compaction and earthfill. It could have been one of several contractors who had been in-

After inspection, specialists from the POLYPLASTIC Group concluded that all the pipe joints had maintained their integrity and soundness, despite the critical deformation during the last 1.5–2 years.

The POLYPLASTIC Group offered a simple and effective solution to eliminate the ovality. Adjustable wooden jacks were installed inside the pipe. The vertical diameter of the pipe was

restored to the standard value with lateral wooden planks. Then the layered backfill and compaction was undertaken to standard requirements. The jacks were removed after the backfill.

Control checks of pipeline ovality were conducted one month after completion of the work, in the presence of representatives from the POLYPLASTIC Group, the design company, the customer and the contractor. The tests showed ovality was no more than 0.5% and the pipe joints had retained their integrity.
