TESTED BY THE ELEMENTS

A PLASTIC GAS PIPELINE HAS SURVIVED TWO FLOODS

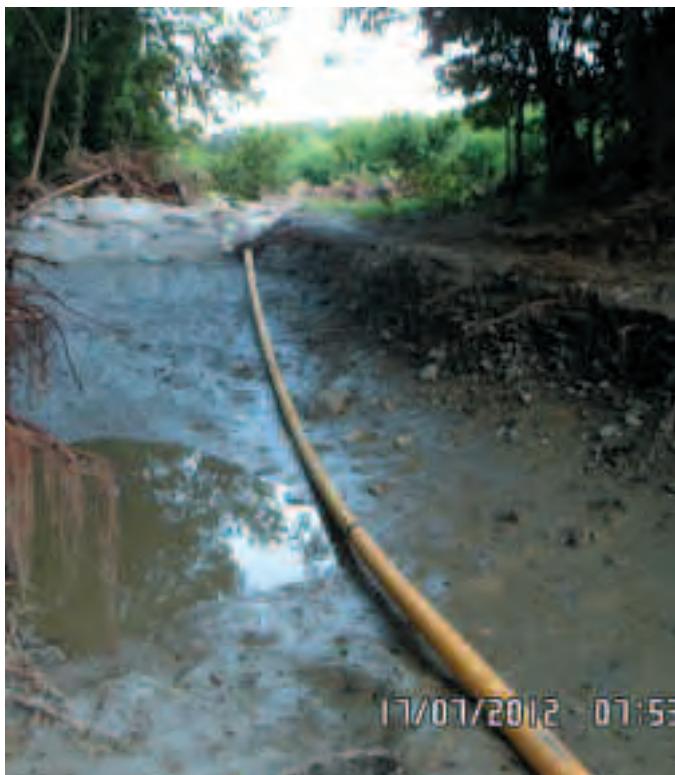
However, the plastic pipeline withstood the impact, even the open parts of the pipelines that were not yet laid into their trenches were intact. In some places the protective jacket was damaged or partially torn but the survey showed that the pipe itself has maintained its integrity.
